Safety, Health and Environment (SHE) Flash

| Flash Date: | 1 st March 2021 | Date to remove: | 29 th March 2021 | Ref: | SHE Flash FY21 003 T2K Operator Tray Removal |

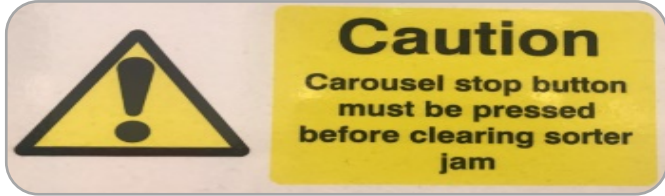
| A Tray jam occurred which the operator attempted to remove/reset without stopping the carousel. This resulted in the trays becoming dislodged and significant damage to the machine - risking injuring to our colleague(s). | <p>Stop the Sorter carousel from the jammed area by pressing the latching stop button at the appropriate location</p> |

Brief employees on the correct procedure to follow. Carousel stop button must be pressed before clearing sorter jam. Never attempt to clear a tray jam on the moving machine.

| Correct procedure not followed. Stop the carousel and remove / reset the jammed tray using the helping hand' grabber tool only once machine has come to a full stop. | |
